**Product Improvement Program W08-104**

**Date:** December 10, 2008  
**To:** Manitowoc Lattice Crane Distributor Service Managers  
**Subject:** #79A Top Inspection, Repair and Modification  
**Model Affected:** 18000

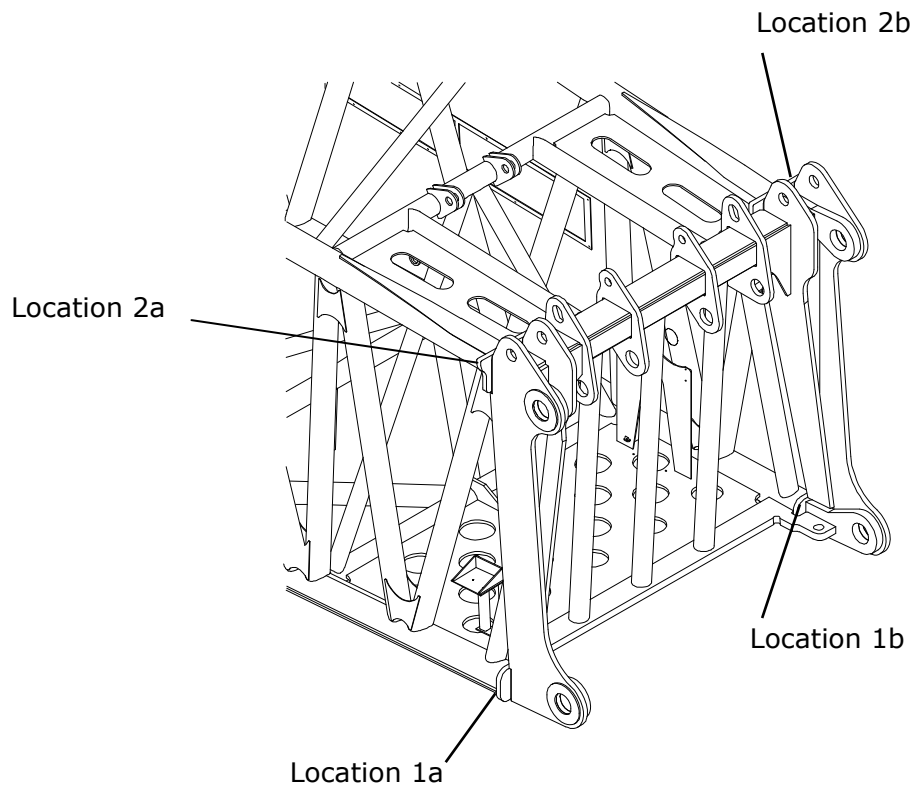
**Figure 1: Location of Chord Mounting Pads and Welds Which Must Be M.T. Inspected**

Manitowoc Cranes has learned that the chord mounting pads on the head section of the #79A tops on the above-referenced Model 18000 cranes and luffing jibs may delaminate. Manitowoc has also determined that the #79A tops may be missing internal welds in the plate work of the head section which may cause cracks to develop in the welds between the chord mounting pads and plate work. Units with delaminated boom chord pads and/or cracked welds at these locations may be structurally compromised and must be immediately taken out of operation.

Immediately contact customers with affected #79A tops and advise them that their affected tops must be taken out of operation. Then immediately schedule and perform M.T. of the chord mounting pads at all four corners of the head section (locations 1a, 1b, 2a and 2b in Figures 1 and 2) and all welds for each of those four chord mounting pads (again at locations 1a, 1b, 2a and 2b in Figures 1 and 3). Instructions for M.T. of these locations are attached to this Product Improvement Program (See Instructions for Non-Destructive Testing M.T. of 79A Tops below).

Regardless of whether any indications of boom chord mounting pad delamination and/or weld cracks were found during the Magnetic Particle Test inspections, all affected #79A tops must be immediately scheduled to have Manitowoc personnel install gussets on the bottom chord mounting pad locations (locations 1a and 1b on Figure 1). All gusset installations required under this Product Improvement Program shall only be performed by Manitowoc personnel. Contact the Crane Care Lattice Team at 1-888-499-7278 to make immediate arrangements to have this modification completed.

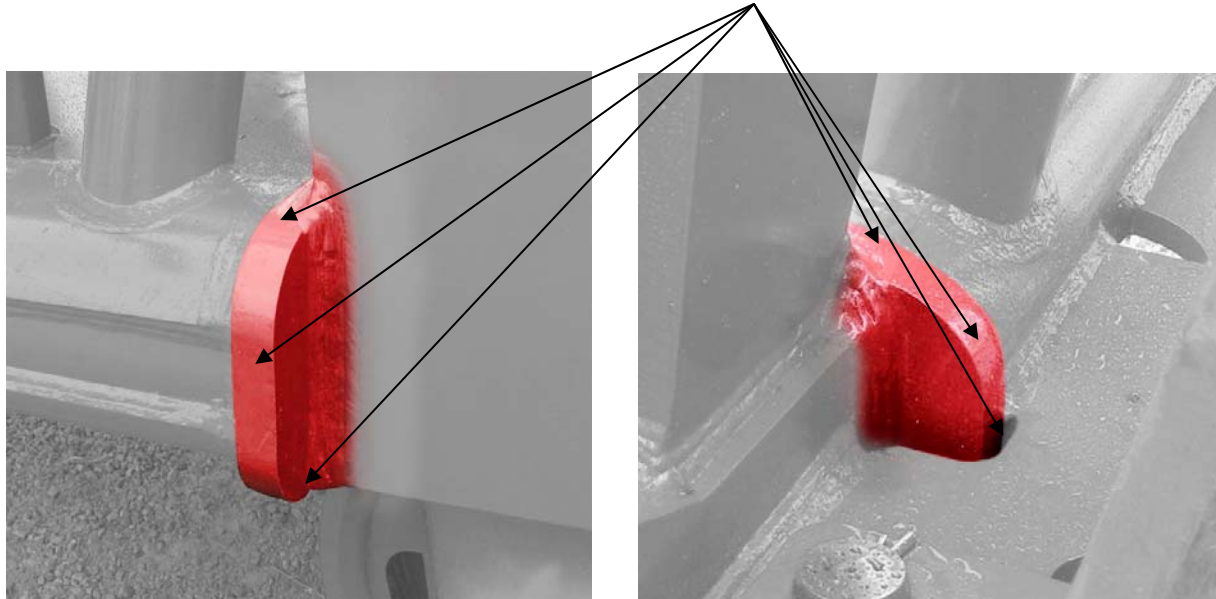
**Figure 2: M.T. Inspection of Boom Chord Pad for Possible Delamination.** Magnetic Particle Test the entire exposed edge of the boom chord pad.

Outboard Side of Lower  
Boom Chord Pad

Inboard Side of Lower  
Boom Chord Pad

If M.T. reveals any indications of delamination of the chord mounting pads and/or any indications of weld cracks, then the #79A top must be kept out of operation until Maniowoc personnel have repaired any boom chord pad delamination and/or cracked welds. Contact Crane Care Lattice Team at 1-888-499-7278 to immediately schedule those repairs. If no indications of boom chord pad delamination and/or weld cracks are detected through M.T., then the #79A top may continue to be used in accordance with the Temporary Use Criteria set forth in Section C (but only on a short term basis until the mandatory modifications, i.e., gusset installations, to the affected #79A tops described in Section B of this Product Improvement Program can be scheduled and completed).

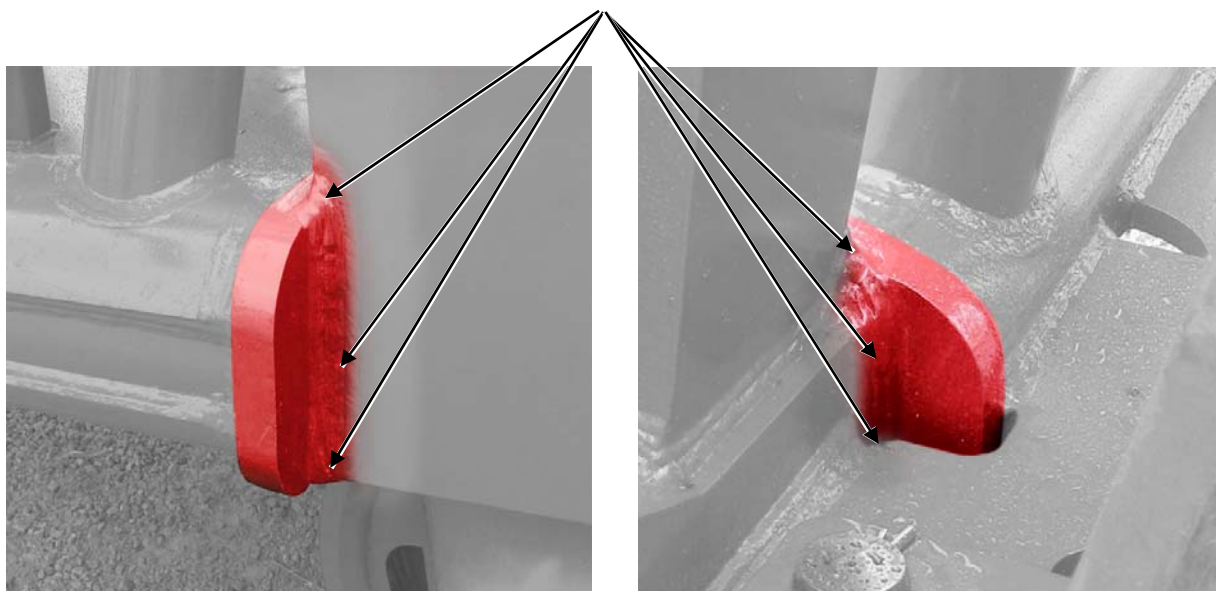
**Figure 3: M.T. Inspection of Chord Mounting Pad for Weld Cracks.** Magnetic Particle Test the entire weld around both the outboard side and inboard side of the Boom Chord Pad.

Outboard Side of  
Lower Boom Chord

Inboard Side of Lower  
Boom Chord Pad
